#17 PENNSYLVANIA AVE.

BA-1445
MAGI# 0314454611

INVENTORY FORM FOR STATE HISTORIC SITES SURVEY

17 West Pennsylvania Avenue, *Smith Building*

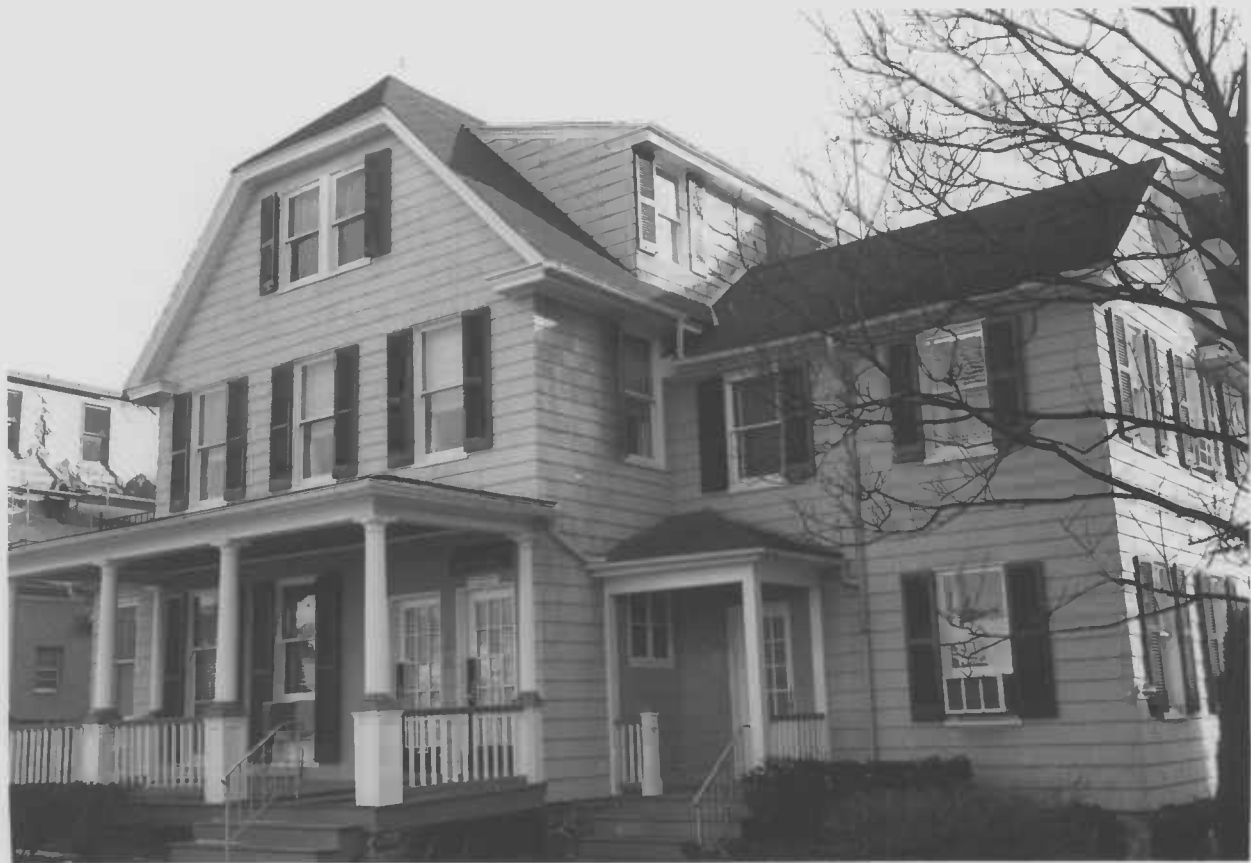
17 W. PENN A. Ave
N.

The North facade is five bays wide, including the 1935 addition. The addition is two bays wide, and is set back one bay from the front of the house. The original part of the house has a porch on the first story that is three bays wide. The four supporting columns are doric and the pedestals are paneled. Under the porch there is lattice work, and three stairs for reaching the two side-hall entry doors. There are two long, triple-hung windows beside the two doors. One door may not be original, since the building has been converted into first and second story offices. The doors are identical. They are long, fifteen paned glass doors. Above the porch, on the second story there is regular fenestration in the three, 1/1 sash windows. In the gable, there are two side by side 1/1 windows smaller than those on the second floor. There are deep cornices on the front gable. There is a small, one bay addition to the Northeast of the main part. It is one story tall, with one 1/1 sash window, and a balcony for the second story French door. Its foundation has been covered with rock-faced form stone. On the Northwest side of the main form is the 1935 addition. It has a one bay porch; as on the large porch, it has three steps leading up to it. There is one 1/1 sash window to the West of its door, and two similar windows on the second story. All of the windows with the exception of the window on the very small addition, have shutters.

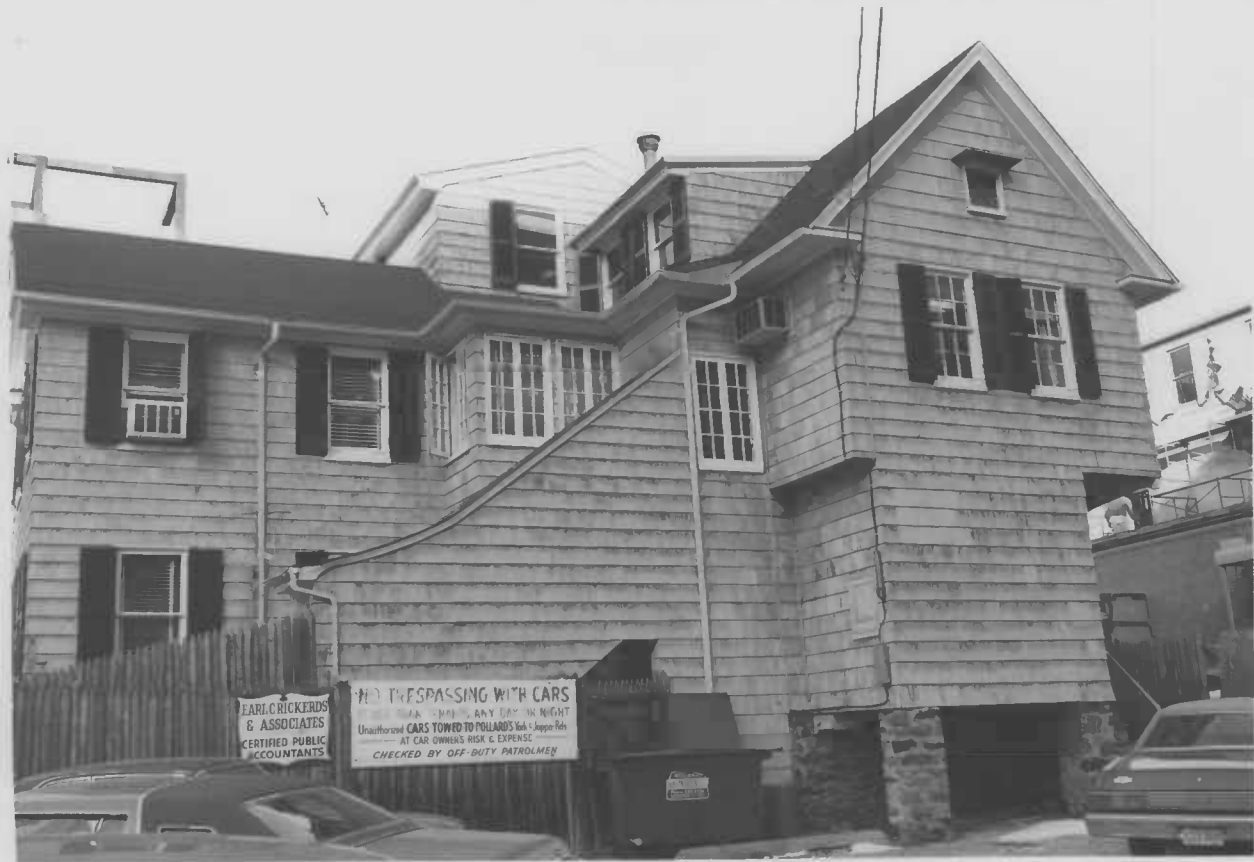
17 W. PENNA. AVE.
S.

The South facade is also very irregular in plan. The Southwest portion is the back side of the addition and it is two bays wide. On the first floor, there are two 1/1 sash windows, identical to the two 1/1 sash windows on the second floor. To the East of this, on the second story are two pairs of 8-paned casement windows. Above this, on the South side of the large dormer is a 1/1 sash window. The cat slide roof is seen in profile. To the East of this is the back side of the main part. It has no windows on the first story. On the second story, there are two 6/6 sash windows. In the deep-corniced gable there is a small single paned window. This portion of the house is supported by stone piers. There is a door on the Southeast corner and steps leading up to it. There is a pair of 8-paned windows on the side projection between the main part of the house and the addition.
